Safety Alert - Swing-Up Stabilisers

October 2021

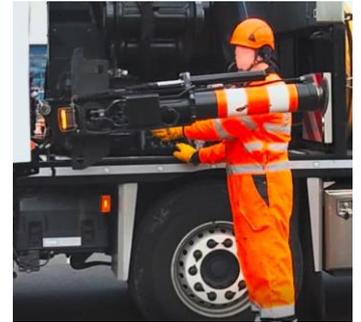
Operator stowing swing-up stabiliser using levers at the crane base

- Swing-up stabilisers should be pinned / locked in the vertical / upright position before the stabiliser beam is deployed or retracted.
- It is essential that Operators fully observe the operation of the stabiliser leg during deployment and stowage.

- Operators must be made aware that the operation of the swing-up function must be separate from the movement of the stabiliser beam (i.e. they should not use both functions simultaneously).

- The risk of crushing is increased on the side where the swing up stabiliser tilts towards the Operator / levers at the crane base.
- Operators must be fully conversant with the manufacturer's instructions regarding the deployment and stowage of swing-up stabilisers. There can be considerable variation between different manufacturer systems.

- Operators must not be positioned in (or lean / reach into) danger zones where there is a risk of crushing.
- If swing-up stabilisers are used on sites where the stabiliser is only partially deployed, there is an increased risk of creating a danger zone where the swing-up stabiliser tilts towards the Operator / levers at the crane base. In this case, consideration should be given to repositioning the vehicle to ensure further extension of the stabiliser beam is achievable prior to the swing-up leg being deployed / stowed.

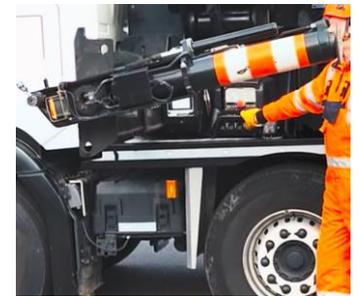
Location of levers at the crane base
